### Kenai National Wildlife Refuge Contaminant Assessment

Tiffany A. S. Parson

January 2001

U.S. Fish and Wildlife Service 1011 East Tudor Road Anchorage, AK 99503

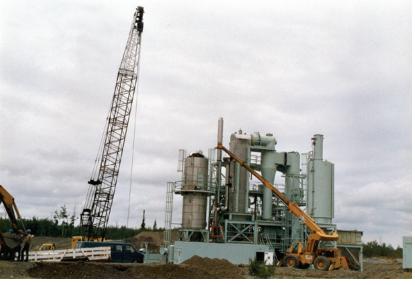
Circulating bed combustor. USFWS Photo by Robert A. Richey.

The circulating bed combustor operated from 1987 to 1992 and incinerated over 107,000 tons of PCB contaminated soils.

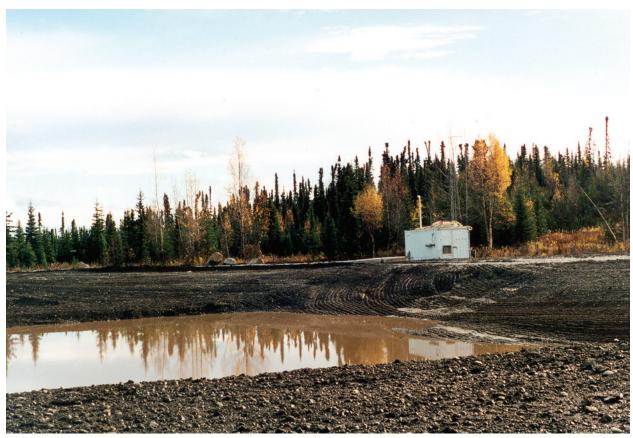
Incomplete engineered wetland at the Pipe and Supply Yard at Swanson River Field. USFWS Photo by Tiffany A. S. Parson.

microbes breakdown organic contaminants. During summer 2000, wetland construction was completed.

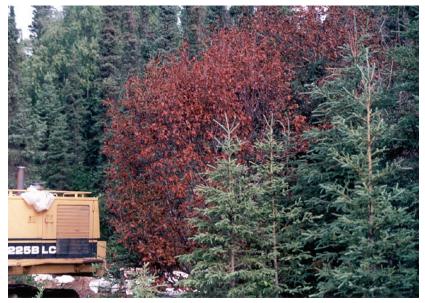
The high salt content in produced water can stress vegetation, as seen by the red leaves of this alder. USFWS Photo by James E. Frates.

On November 21, 1999, there was a leak in a 6" underground fiberglass pipeline used for transporting produced water to the wastewater disposal facility at tank setting 1-33. The spill occurred near the tank setting 1-4 wastewater building approximately ¼ mile from the Swanson River (ADEC spill number is 99239932501).

The spill was estimated to contain 8,600 gallons of produced water with less than one gallon of oil (ADEC, Prevention and Emergency Response Program, http://www.state.ak.us/local/akpages/ENV.CONSERV/dsparperp/unocal/status\_03.htm). The produced water flowed through a culvert to an interception basin across the road. Approximately 7,000 gallons of produced water were recovered from the interception basin using a vacuum truck. The remainder of the produced water escaped the basin and flowed toward the Swanson River. Based on visual observations, the spill impact area appeared to extend to within 50' to 100' of Swanson River. Soil samples did not exceed ADEC's soil cleanup levels except for two samples closest to the spill, which exceeded the benzene cleanup levels. These locations will be resampled in the spring of 2000.

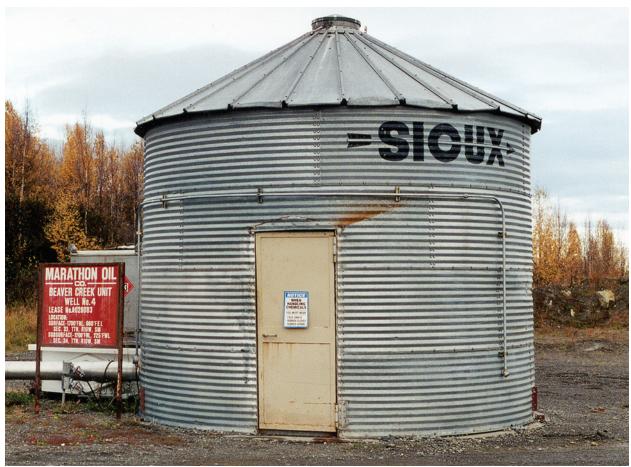
Beaver Creek Field Well Number 4. USFWS Photo by Tiffany A. S. Parson.

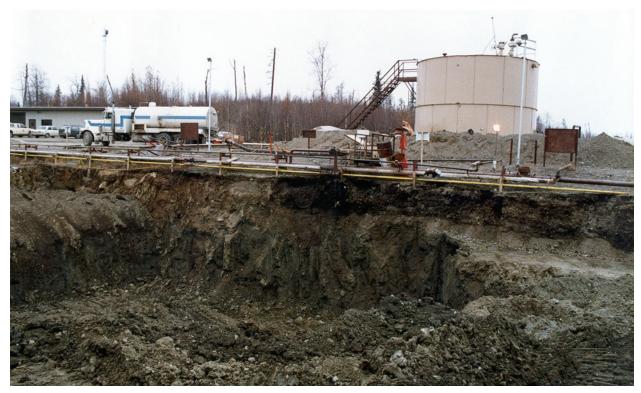
Excavation of contaminated soils resulting from the tank farm spill. USFWS Photo by Robert A. Richey.

The excavated material (about 5,000 cubic yards) was transported to BCU Pad 7, where it was placed on an impervious liner and later

incinerated. Periodic sampling of monitoring wells around the perimeter revealed no contamination of groundwater. The site was refilled with gravel and today is part of the industrial storage area at the Beaver Creek headquarters complex.

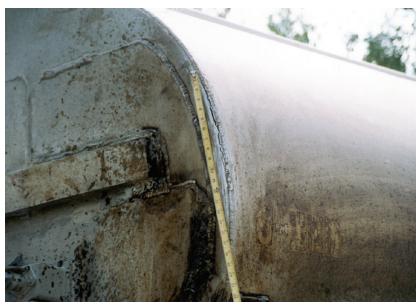
A 14-inch break in the forward bulkhead of this fully loaded tanker resulted in spilled crude oil along Marathon Road within the Beaver Creek Field. USFWS Photo by James E. Frates.

On July 22, 1993, a 800 bbl capacity truck-tanker, owned by Jackson Construction Co., left the loading ramp with approximately 400 bbl of crude oil en route to the Tesoro Refinery. While approaching the bridge over the north fork of Beaver Creek, the driver noticed a dark mist coming from the vicinity of the tanker's forward bulkhead. When it became apparent that the mist was actually crude oil coming from a hairline crack in the forward bulkhead, the driver transferred crude to another compartment to keep the liquid below the crack. Total loss was estimated at less than 40 gallons. Personnel used shovels and buckets to retrieve contaminated gravel, which extended over a distance of approximately ½ mile.

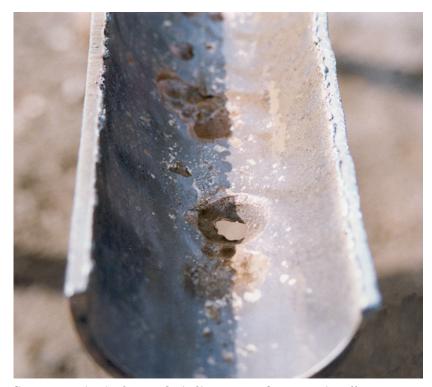
Severe corrosion in the 2-15 drain line prompted an extensive effort to determine the integrity characteristics of other long-buried lines within Swanson River Field. USFWS Photo by James E. Frates.

One of the main concerns at SRF is the integrity of aging flowlines and drain lines. The SRF was established in 1957, and throughout the years many leaks/spills have occurred due to the corrosion of aging lines. Additionally as the field ages, the ratio of salt water to crude increases, and this higher salt water content expedites the corrosion of lines. The current unit operator, Unocal, is trying to remedy this situation by using chemical additives, inserting polyethylene liners into the existing flowlines and gathering lines and replacing older lines. Although the unit operators have made considerable efforts to repair/update/replace these lines and implement cathodic protection systems, the potential for leaks from aging lines still exists.

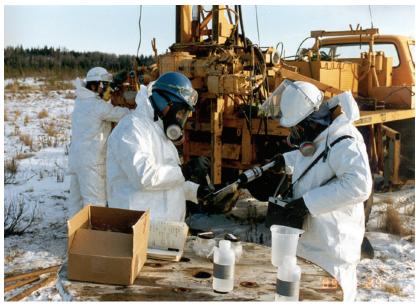
Over 1,000 soil samples were collected in association with the extensive PCB remediation efforts at Swanson River Field. USFWS Photo by Robert A. Richey.

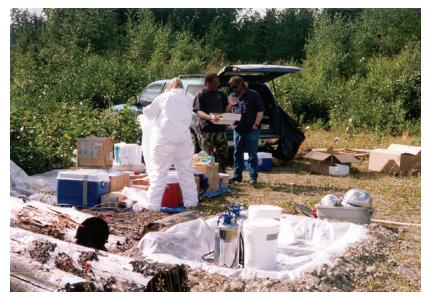
Site investigation for pentachlorophenol contamination at the Moose Research Center. USFWS Photo by James E. Frates.

spruce posts were soaked in a mixture of PCP and diesel fuel to prevent the poles from eventually rotting. Prior to being placed in the ground, the butt ends of the poles were soaked in sealed concrete culverts for several days. The treatment location is known as the Swan Lake 1 exploratory well drill site (an abandoned oil well pad drilled in 1961).

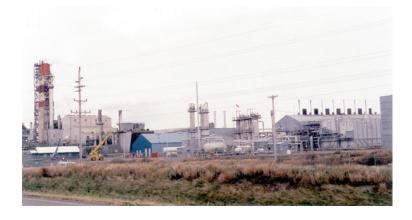
Agrium facility. USFWS Photo by Tiffany A. S. Parson.

In 1997, the Unocal Agricultural Facility (now Agrium) released more air emissions than any other facility in Alaska, emitting 3,481,219 pounds of chemical (96% ammonia). One concern noted by refuge personnel is the release of ammonia from the Agrium facility. The ammonia air releases from 1987 to 1997 are displayed in Figure 7. According to the 1997 Toxics Release Inventory (TRI), this facility released more air emissions than any other facility in Alaska, emitting 3,481,219 pounds of chemical (96% ammonia). Historically, plant upsets caused releases of ammonia above permitted levels (ENVIRO, Unocal Speaking of the Environment, January 1998). However, since 1986, Unocal has worked to continually reduce their ammonia emissions through system upgrades and installing flares. According to a Unocal publication entitled ENVIRO, Unocal Speaking of the Environment (June 1999), "flares have dropped ammonia releases due to plant upsets by 97 percent." Potential impacts of these historic and ongoing ammonia releases on refuge resources are unknown.

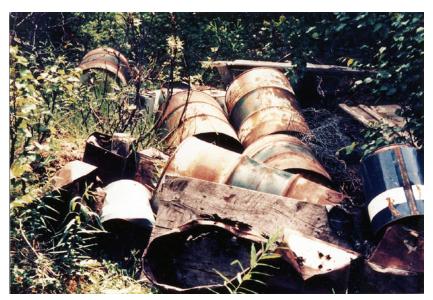
Fifty-five gallon barrels at the Surprise Creek gold mining area prior to removal efforts in 1987. USFWS Photo by Richard K. Johnston.

Some contaminants of concern at this site include mercury, cyanide, PCBs and calcium carbide. Additionally, explosives are a potential concern at this site. PCBs could be present in Alaska Diesel because additives, such as PCBs, were often added to Alaska Diesel. Calcium carbide was used in headlamps and other portable lighting systems. When calcium carbide is exposed to moisture, acetylene gas is produced. According to the material safety data sheet (MSDS) for calcium carbide, acetylene is rapidly produced from carbide and water and is considered hazardous because of its flammable and explosive properties (http://svis.org/caving/wvusg/calcium.htm).

A contaminants investigation has never occurred at this site. Due to the history of this site, the potentially hazardous substances identified at the site, and the prior removal efforts, a contaminants investigation may be warranted.

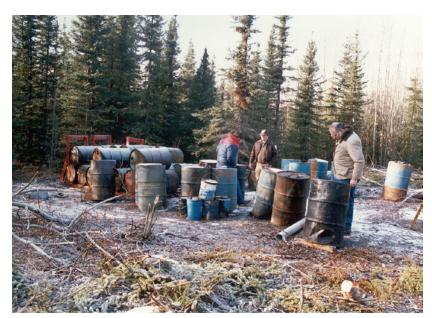
Liquid-filled 55-gallon drums at the Skilak Boneyard prior to proper removal and disposal. USFWS Photo by Robert A Richey.

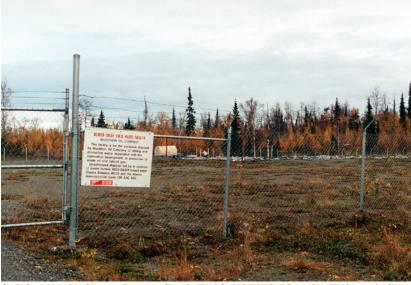
Solid waste facility at Beaver Creek Field. USFWS Photo by Tiffany A. S. Parson.

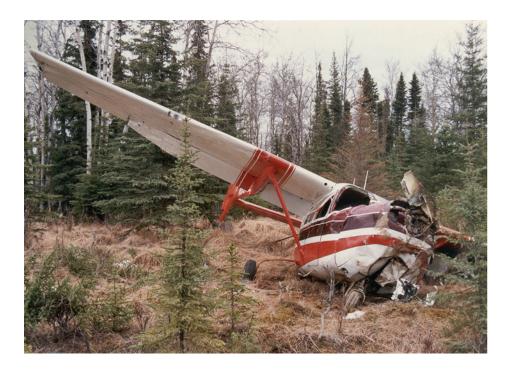
This Cessna 337 crashed on refuge lands after running out of fuel. USFWS Photo by Robert A. Richey.

According to the refuge narratives, from 1948 to 1995 at least 74 aircraft accidents have occurred on the refuge, and this is a conservative estimate. It appears that most of the aircrafts have been removed from the refuge. These crashed aircraft likely pose more of a solid waste issue than a contaminant issue to refuge lands; however, spilled aircraft fuel and lead from unrecovered batteries could be a minor issue.
